Re: March 2015 Monthly Progress Report  
Administrative Settlement Agreement and Order on Consent for Removal Action  
U.S. EPA Region 10 Docket No. CERCLA 10-2009-0255  
Gasco Sediments Site within the Portland Harbor Superfund Site

Attachment A      Monthly Visual Monitoring Report for Pilot Cap Vicinity

## Visual Observations Log Form

**Project Name:** NW Natural – Gasco

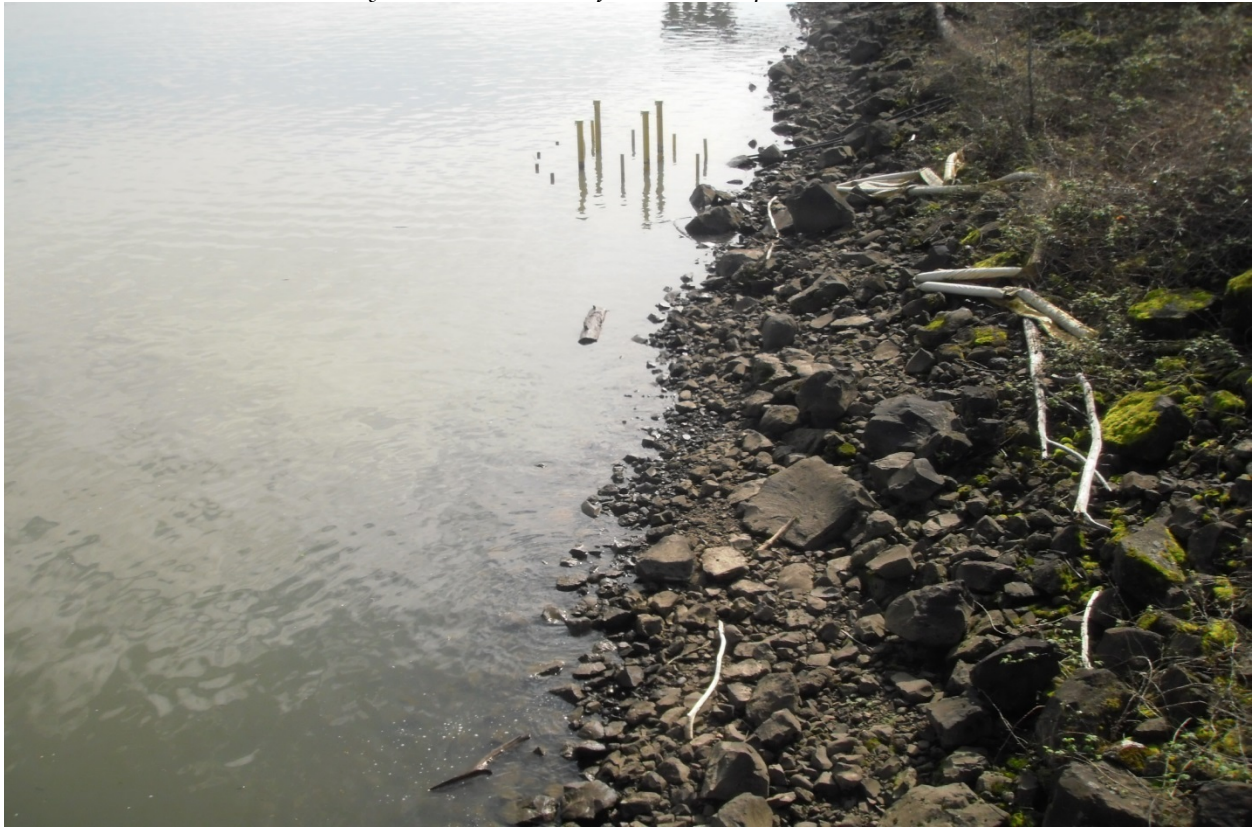
**Observations of Erosion/Deposition:** No erosion/deposition is evident along the shoreline. The shoreward extent of the cap was not visible due to high river water elevation and the extents of the organoclay mat material were also submerged. (Photo 1).

Photo 1 — *River level currently above the extent of sediment cap (3/27/15):*

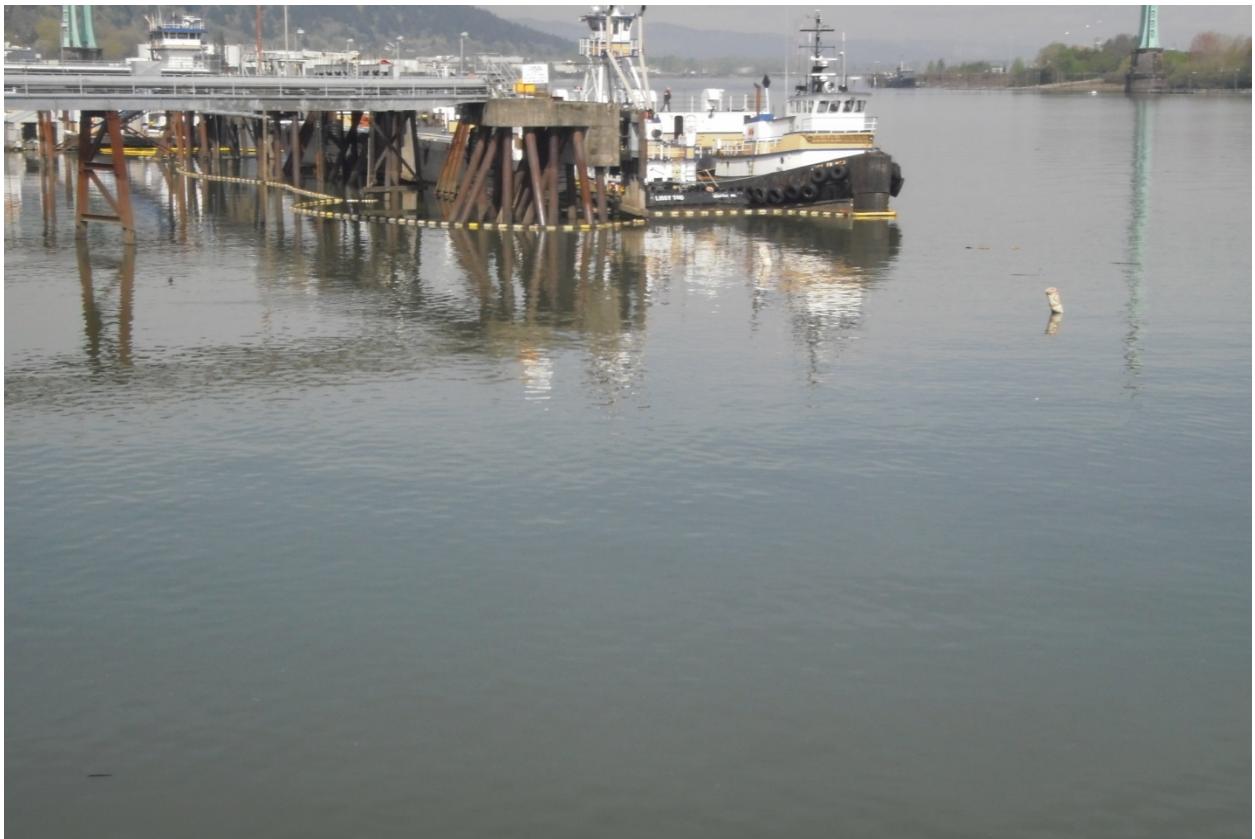
**Observations of Long-term Controls (i.e., oil booms, organo-clay mat, etc.)** During the observation, a barge and two tug boats were tied at the dock and the Fuel and Marine Marketing (FAMM) containment boom was placed around the barge and tug boats. Two buoys that identify the cap area to mariners are in place as installed. The position of the FAMM oil boom, warning buoys, and a general overview is shown in Photo 2.

Photo 2 - *FAMM oil boom around barge and tug boats. Mariner warning buoys in place across pilot cap area. (3/27/15):*

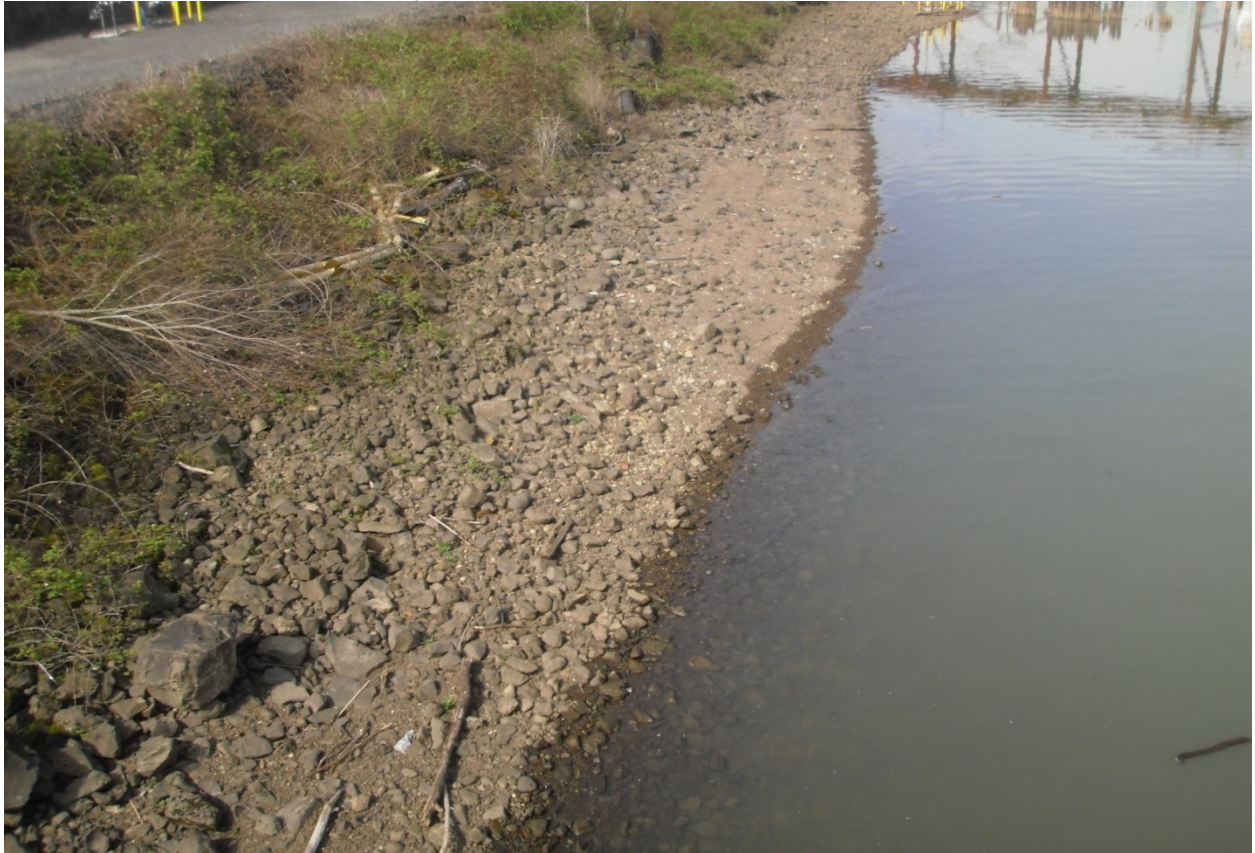
**Other Comments:** No sheen is evident in or around the cap area. Photo 3 shows the water surface and shoreline immediately downriver of the sediment cap.

Photo 3 — *Conditions immediately downriver of cap area (3/27/15):*
